THE COLLABORATION YARD

Connecting society back into the workplace

Sections and elevations

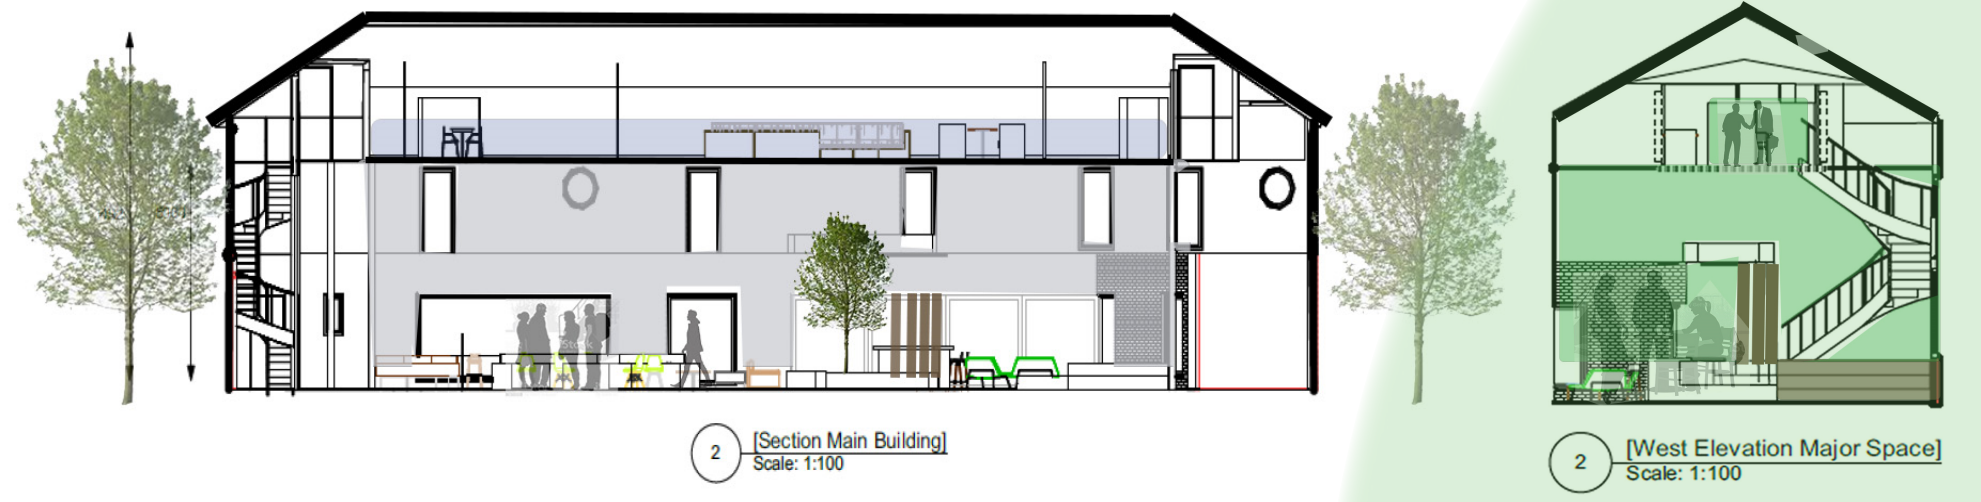
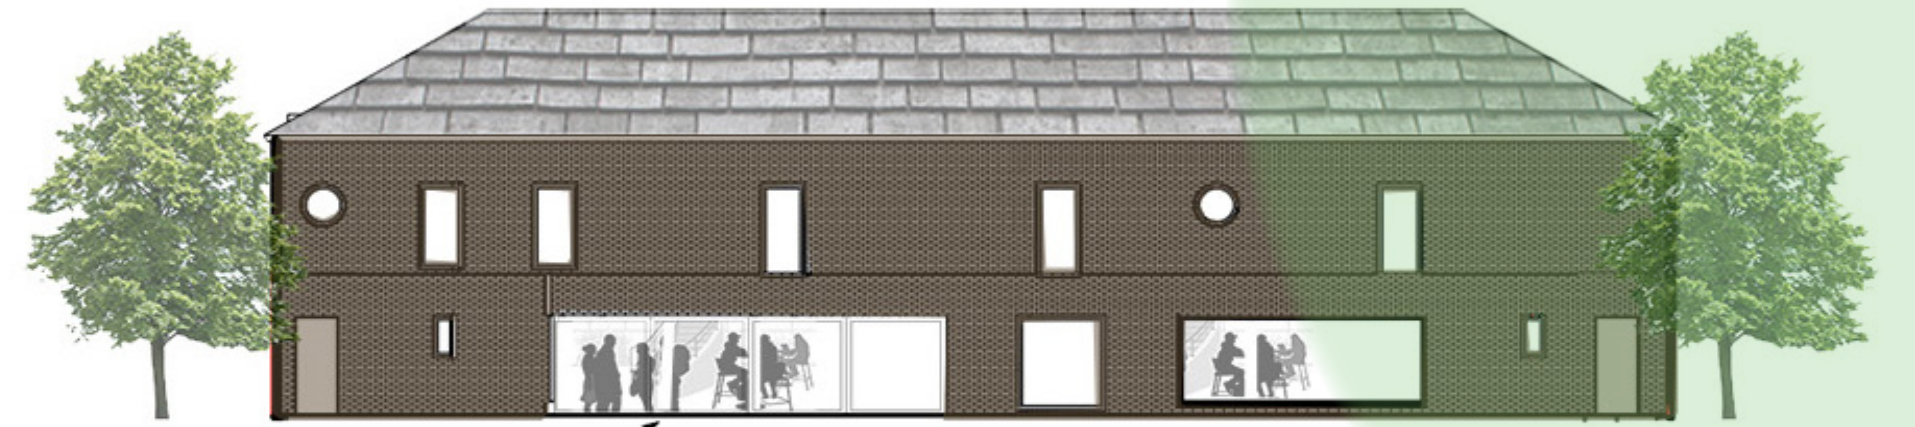
1 [External Elevation] Scale: 1:100

Front windows replaced with four pane bi-fold windows 8000 mm opening to allow natural light to flood front of the building and look out onto courtyard parking/seating area

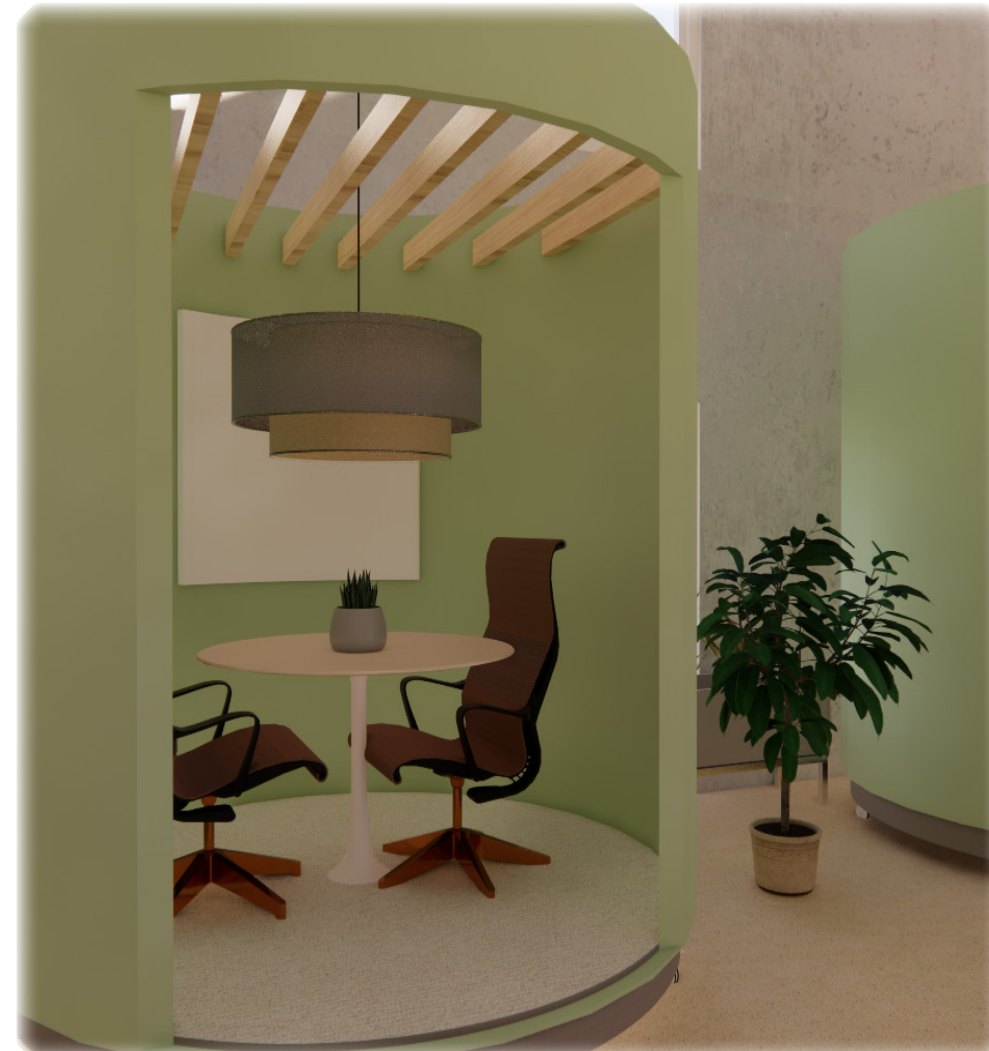
Restoration Pod

A calm restful place for the user to work with fabric covered acoustic walls for good sound absorption on both interior and exterior reducing reverberation rather than complete silence to allow for a restful and muted atmosphere providing restoration. Wooden slatted beams to allow for the natural light to filter through
